**Bridger Range, Ramp**  
**Bridger Range**  
**MT**  
 Elevation: **8000 ft**  
 Aspect: **NE**  
 Specifics: **Ski tracks on slope; We skied slope**

**Spencer Jonas**  
**Sat Nov 11 14:45 2017**  
 Co-ord: **45.82853N, -110.93153W**  
 Slope Angle:  
 Wind Loading:

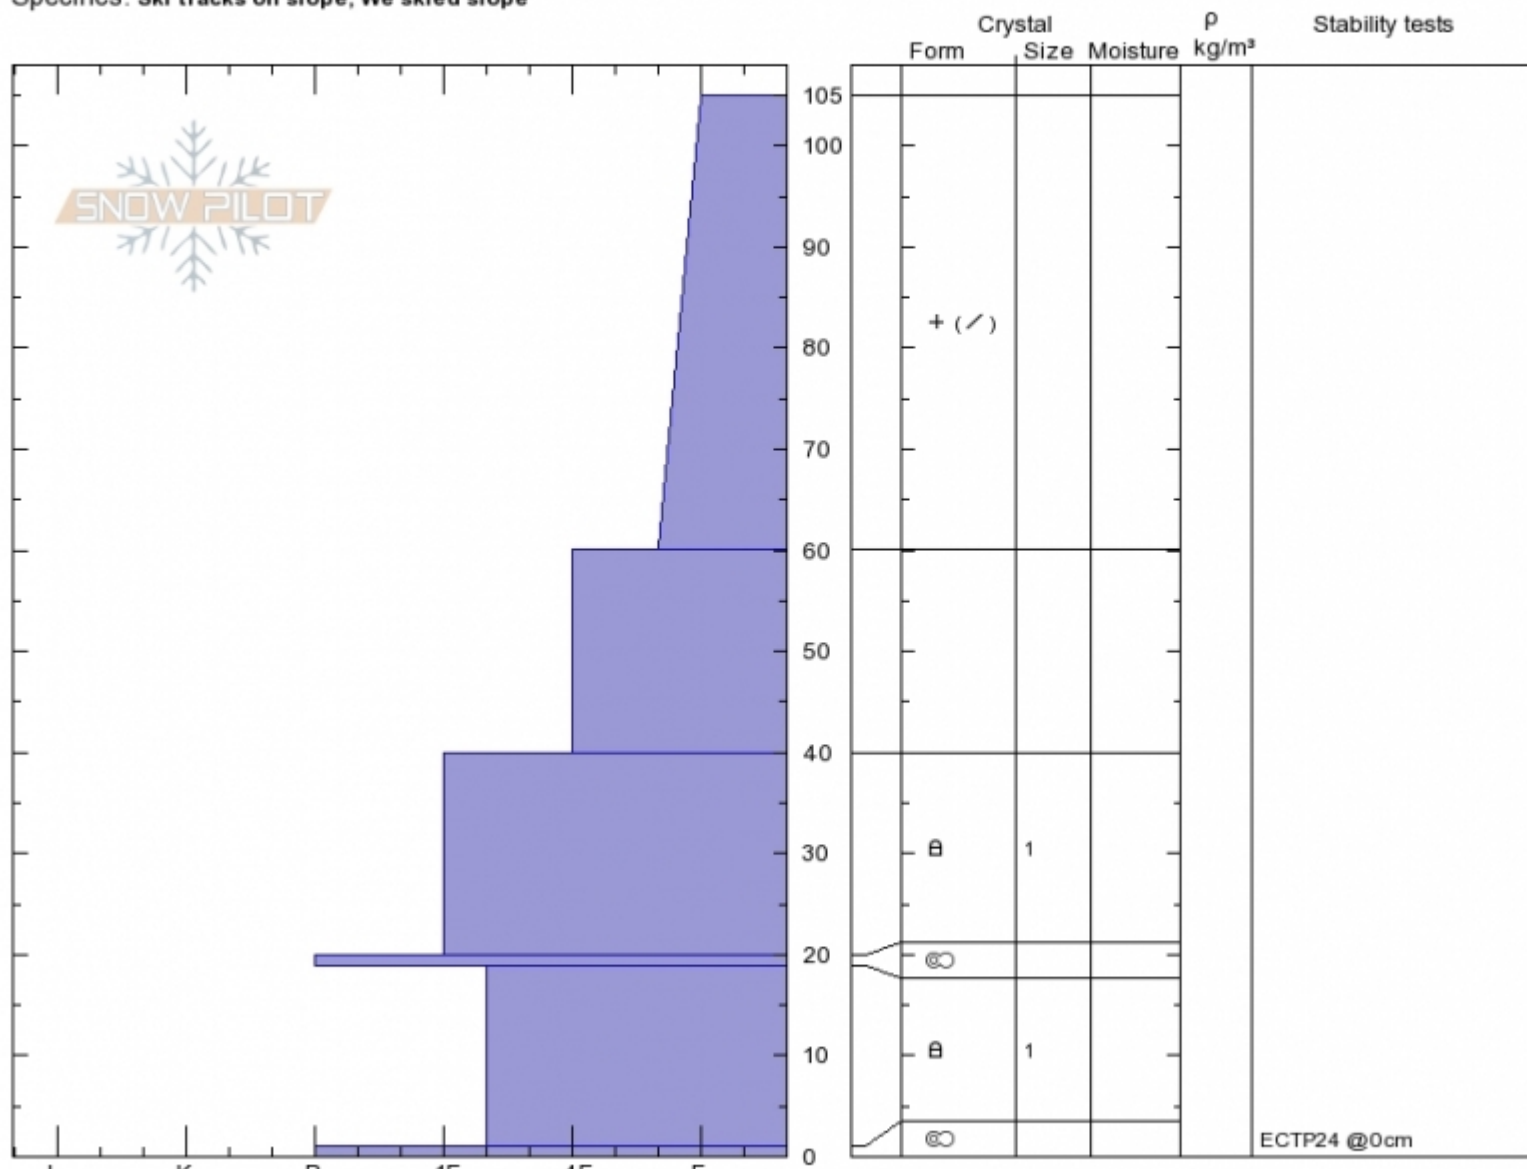
**HS105**  
 Stability Test Notes  
 Layer No  
 1-19: Prob

Notes: There was an air pocket between the ice crust that formed the bottom layer and the ground. The column failed when the ice broke a little ground that it was attached to, a small root and rock at the back of the column. Our layer of concern was the old September snow. There was no sign of instability at its interface. It is hard to interpret the ectp as a sign of instability, it seemed to be more an issue of ground movement specifically beneath the column and not an indicator of overall instability at the ground.
