Advisory Region Southern Madison Longitude -111.10W Latitude 44.96N **Avalanche Details:** <u>Cracking and Collapsing at Bacon Rind</u> **Forecast link:** <u>GNFAC Avalanche Forecast for Mon Feb 5, 2024GNFAC Avalanche Forecast for Wed Feb 7, 2024</u> Southern Madison, 2024-02-04

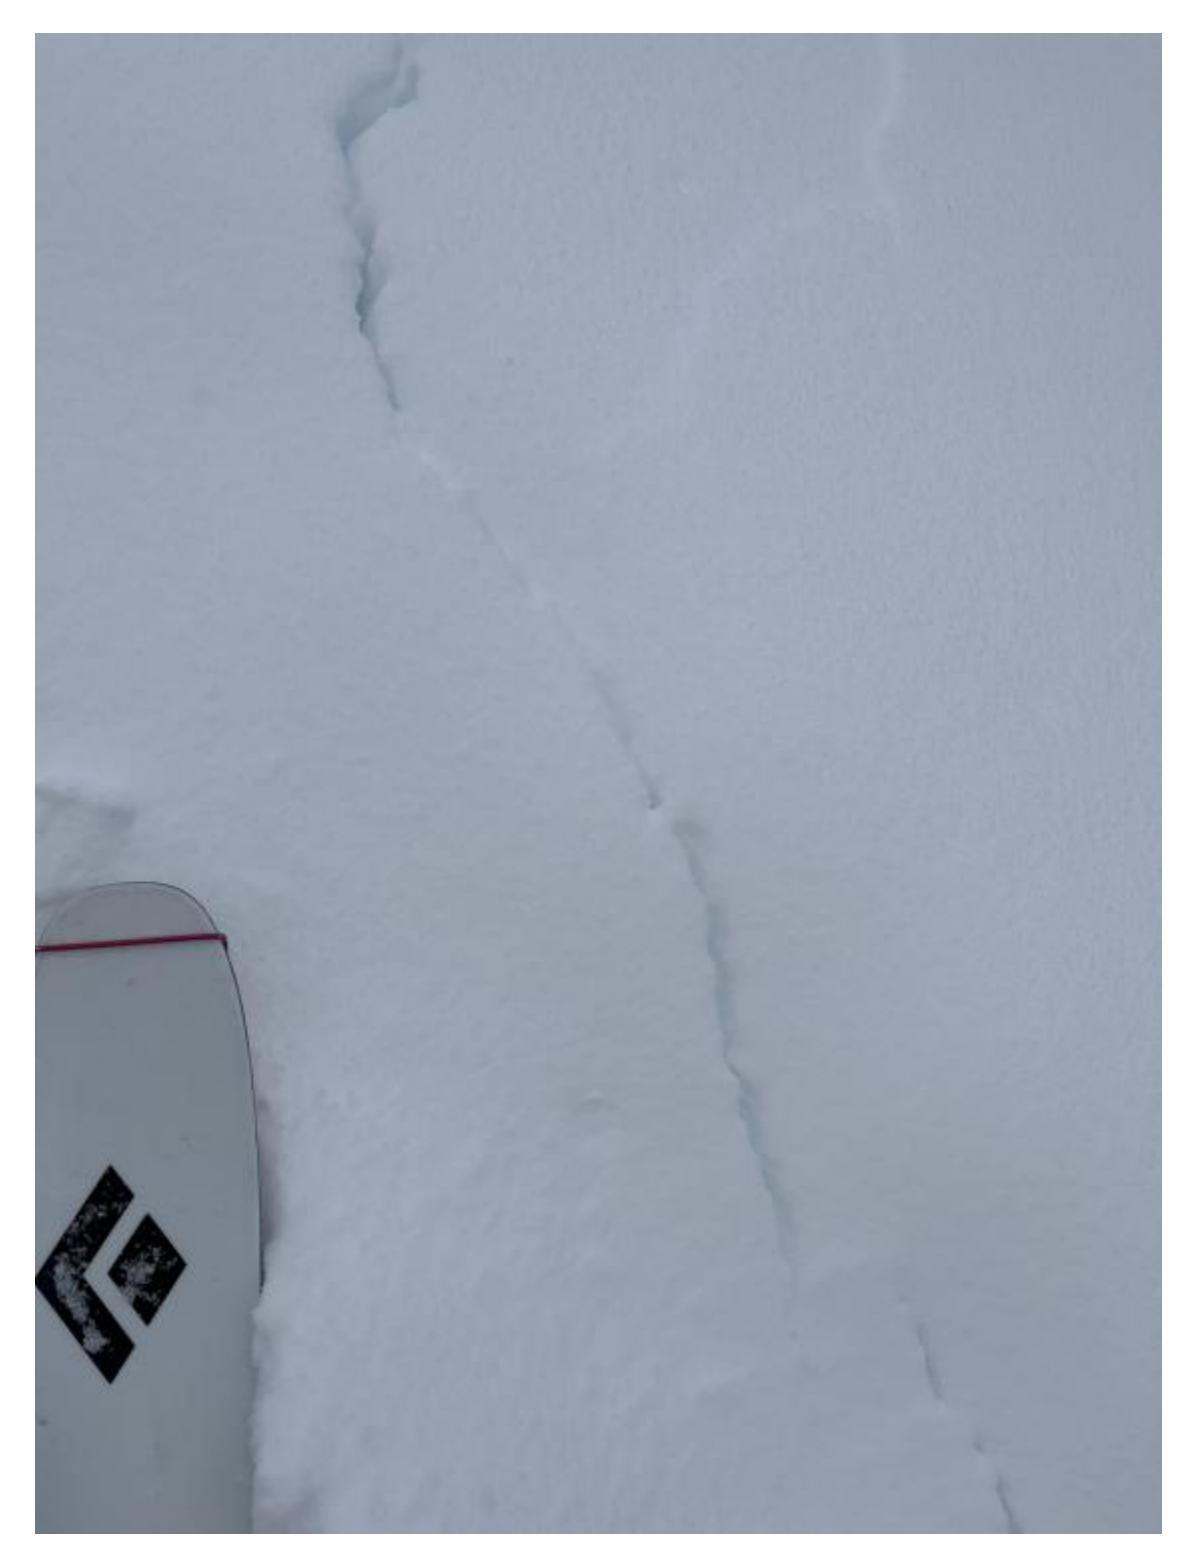
From obs: "We heard numerous large-scale collapses and witnessed the development of propagating tensile fractures on a $20^{\circ}-25^{\circ}$ slope along the skin track.... We skied this location 4 times this week. Each time, we experienced collapsing and fracturing within the snowpack. and stuck to skiing conservative, low-angle lines." Photo: T. Kalakay
