Advisory Region Lionhead Range

Lionhead Range, 2013-01-12

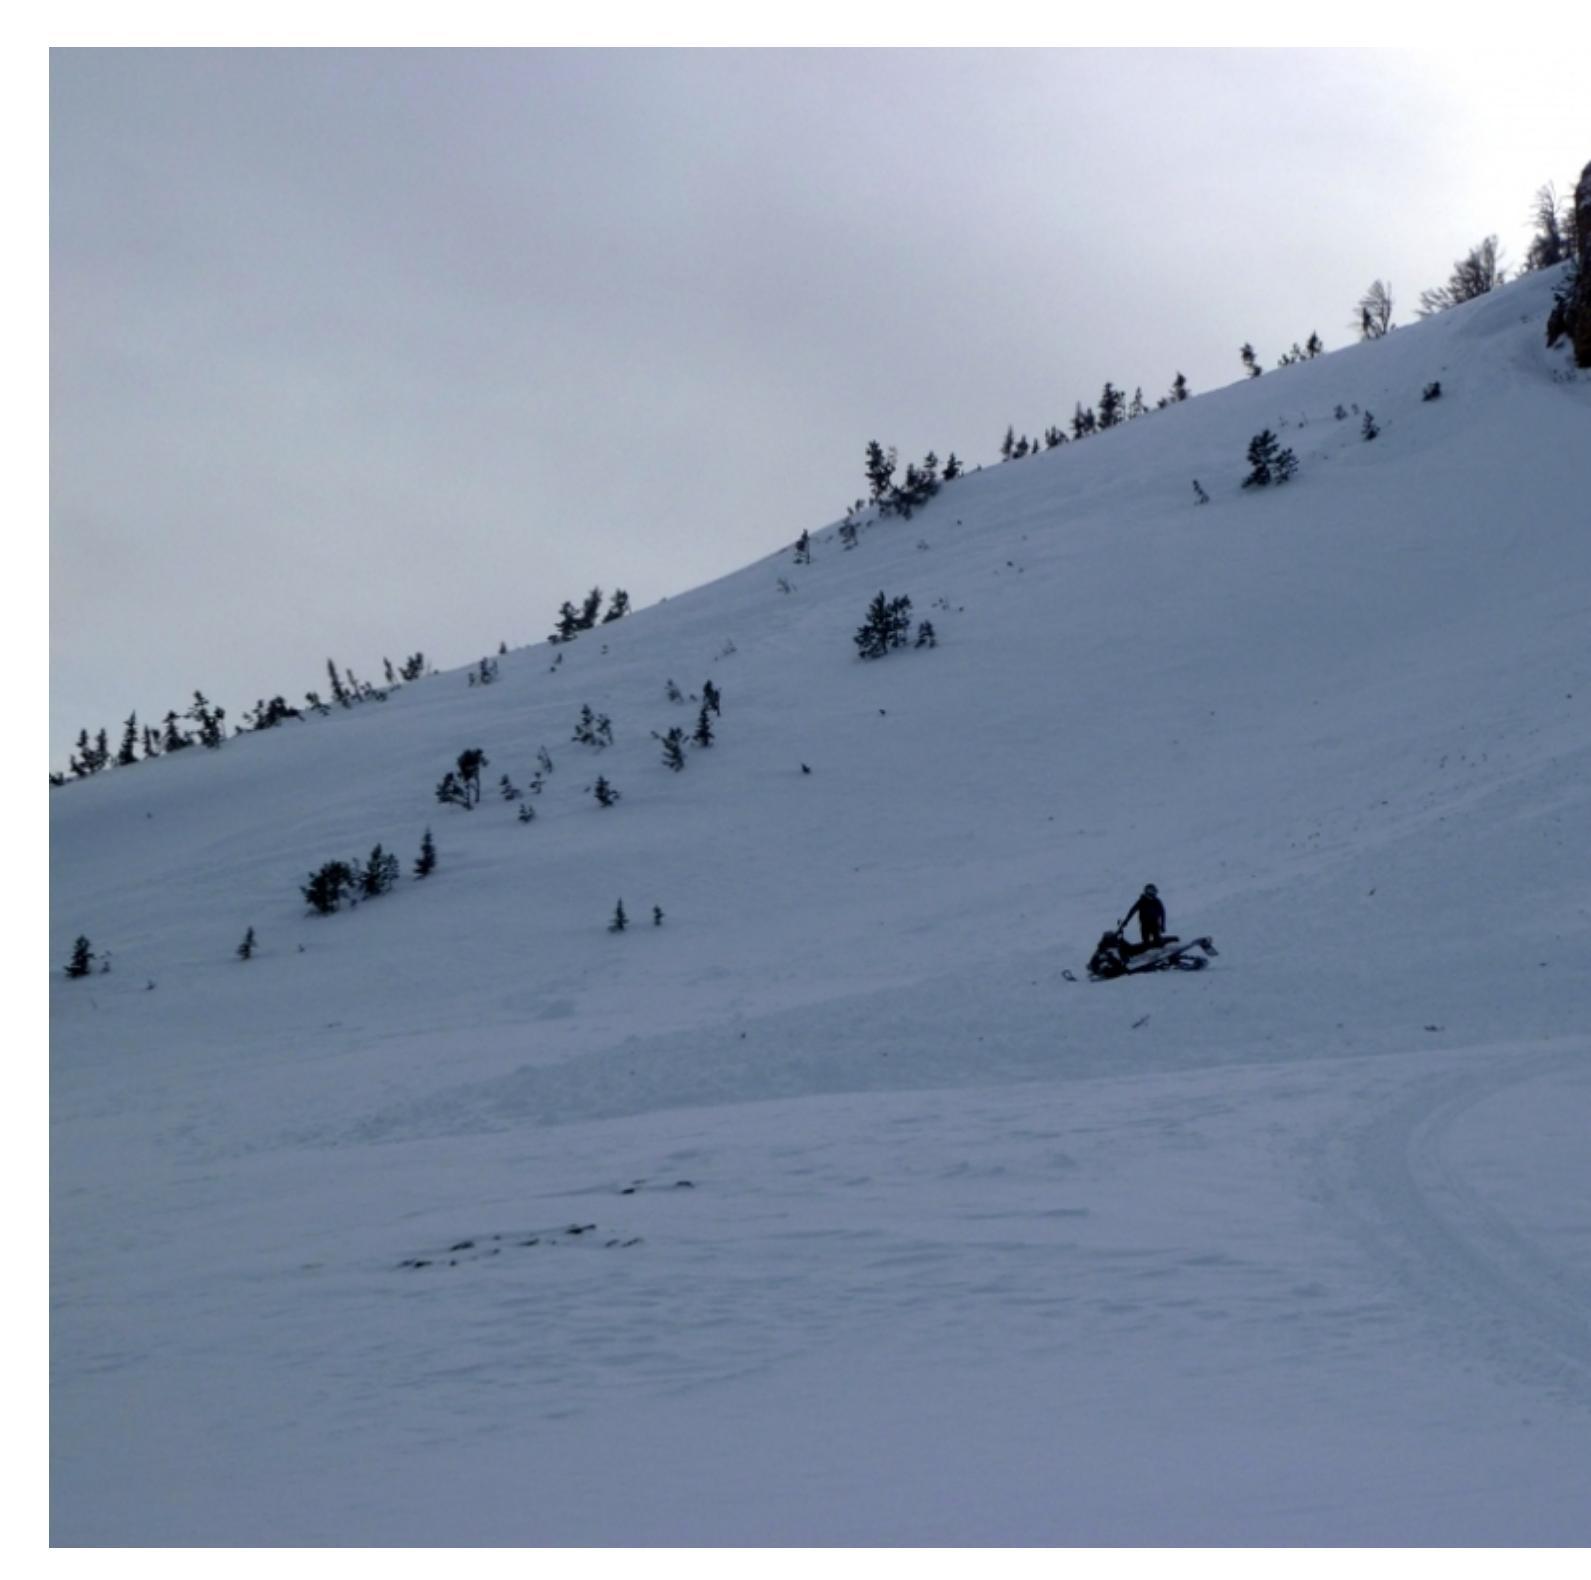
Over a foot of fresh snow produced natural avalanches off the Lionhead Ridge. This slide likely occurred during or immedately after the storm and was the result of a heavy wind load. Photo GNFAC
